**National Highway
Traffic Safety
Administration**

Case Vehicle (A): 1999 Dodge
 Type: Dakota Sport 4 x 2, Club cab 2-door pickup
 Driver: 76-year-old female
 CDC: 11-LYEW-2, 09-LBEW-1

Veh. (B): 1992 Ford
 Type: Ranger 4 x 2, pickup
 Driver: 32-year-old male
 CDC: 99-0000-0, 99-0000-0

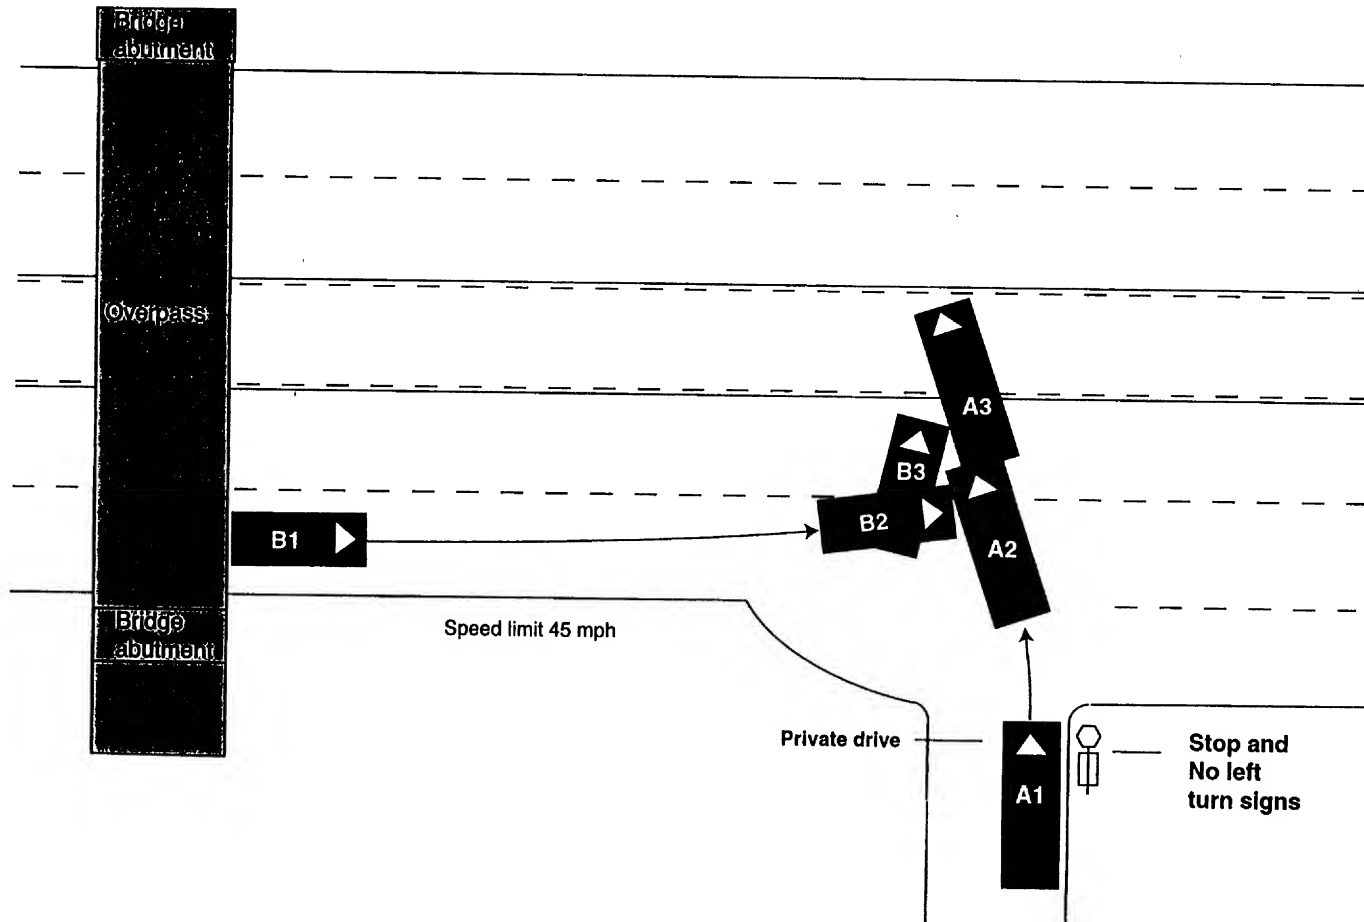
ACCIDENT SCHEMATIC

ACCIDENT DESCRIPTION: Case vehicle (A) was exiting a private
drive when it was struck on left side by
vehicle (B).

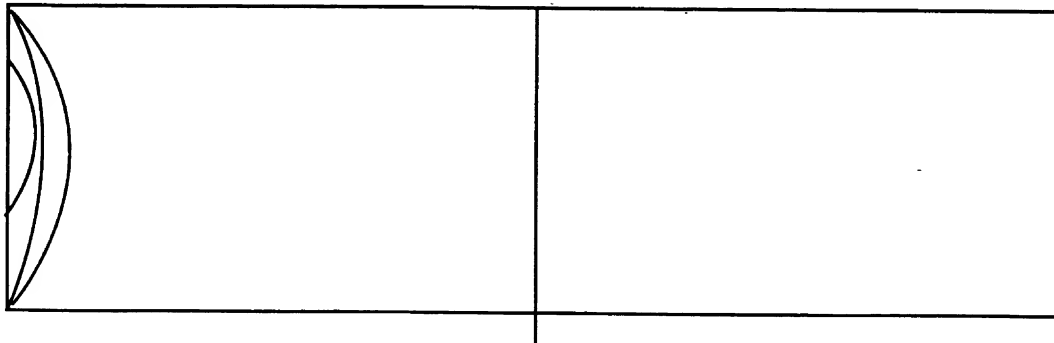
Cracked due to upper A-pillar deformation

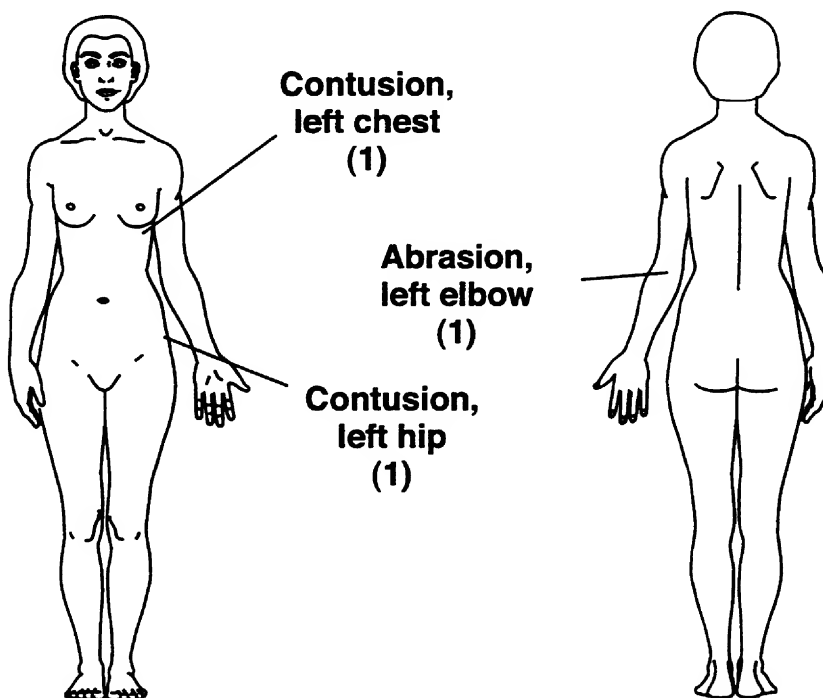
INDICATE LOCATION OF INJURIES.

Injury Description	A.I.S.	Injury Source		
		Definite	Probable	Possible
Contusion, left side of chest	1		Interior panel of driver door	Shoulder belt
Abrasion, left elbow	1		Interior panel of driver door	Airbag
Contusion, left hip	1		Interior panel of driver door	Lap belt
<u>Maximum A.I.S. Level</u>	<u>1</u>			
<u>Injury Severity Score</u>	<u>1</u>
